**US Army Corps
of Engineers**

**USACERL Special Report 97/80
May 1997**

Design and Replacement Guidelines for Historic Properties at Marine Corps Base Quantico, Virginia

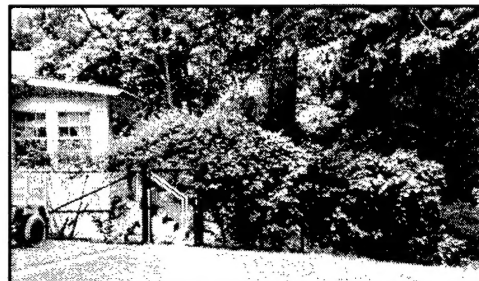
Figure 2. Dark, well-concealed fence helps to maintain site's character.

- Preserve the overall appearance and character found throughout the site. See Figure 2.
- Maintain the integrity of the landscape with any new corridors or buildings that should need to be constructed. See Figure 3.
- Retain the boundaries encompassing the historic districts. For development within these areas, see guidelines for historic district site conditions (next section).
- Improve energy-efficiency and ecology by maintaining existing landscape features that moderate the effects of the climate on the setting (e.g., deciduous trees, evergreen windblocks, and lakes or ponds).

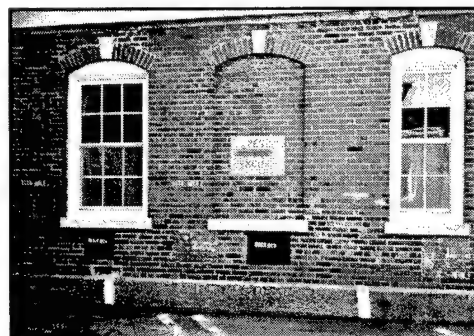
Figure 7. Spray-painted signage is non-compatible and can damage bricks, but this bricked-in window maintains its original character-defining elements and is sensitive to the integrity of the original.

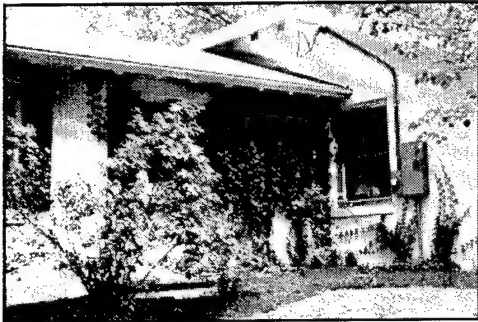
Figure 8. Vines should be cut back to avoid damage to stucco and wood.

- Improve energy efficiency by retaining plant materials, trees, and landscape features—especially those that perform passive solar energy functions such as sun shading and wind breaks. Be sure to prune the landscaping so it will not damage the structure. See Figure 8.

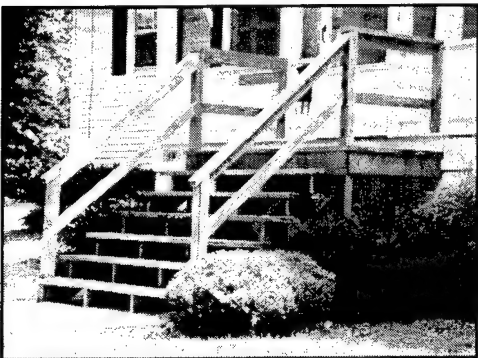
Figure 12. Replacement material and construction of stairs are compatible, but should be painted white to be color-compatible.

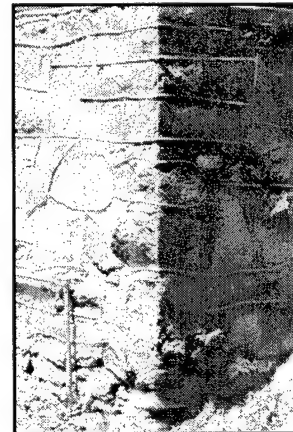
Figure 21. Stone and mortar joint size, proportion, and workmanship of foundation, Harry Lee Hall.

- Maintain sound masonry elements that are important in defining the overall historic character of the building. Remove and replace masonry inconsistent with the original with stone, brick, and mortar to match the original. See Figure 21.
- Analyze existing mortar to specify a compatible mix for repairs. New mortar shall match the old in color, texture, workmanship, and strength. See Figure 22.
- Retain correct joint size and profile for appropriate pointing of historic brick walls.
- Size and orientation of bricks shall replicate the original layout and bond pattern.
- Retain the existing texture and color of masonry surfaces. Maintain any coatings included on the original materials to protect elements that were not intended to be exposed.
- Masonry surfaces shall not be removed. When repair is not practical, replacement of elements shall match the original. See Figure 23.

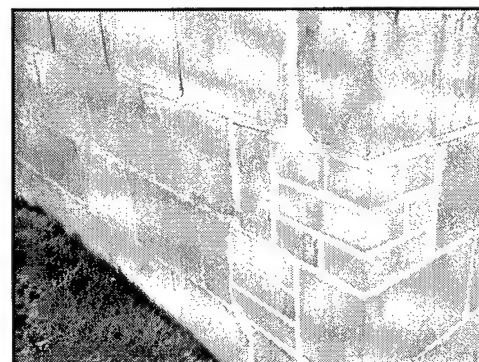
Figure 23. Incompatible masonry units and mortar adversely affect character.

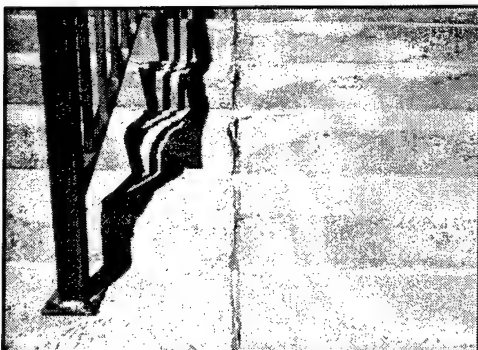
Figure 26. These deteriorated stairs are aesthetically damaging and a safety hazard; they must be repaired with a compatible concrete mixture.

- Point where spalling has occurred. Retain correct joint size and profile for appropriate pointing of historic structural material. See Figure 25.
- Repair concrete steps and stoops where rust damage from ironwork has occurred. See Figure 26.

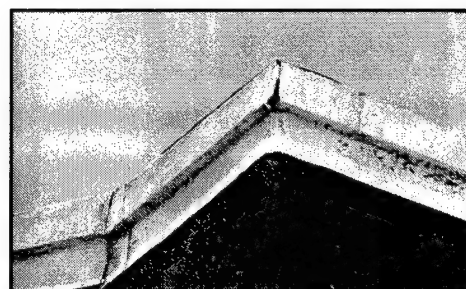
Figure 29. Deterioration will continue if metal is not properly cleaned and coated.

- Metal elements that contribute to the architectural character of the building shall be retained and preserved. Also, retain and preserve the type of finish, its historic color, and accent scheme. See Figure 27.
- Copper and bronze should not be painted or coated. Other metals should be painted to protect them from weathering. See Figure 28.
- Retain rather than replace deteriorated architectural metal elements when repair and limited replacements can be accomplished. See Figure 29.

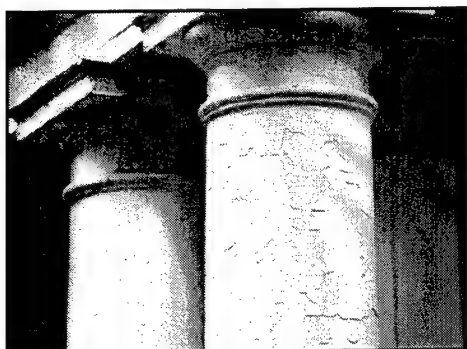
Figure 32. Paint buildup can change the historic character of building elements.

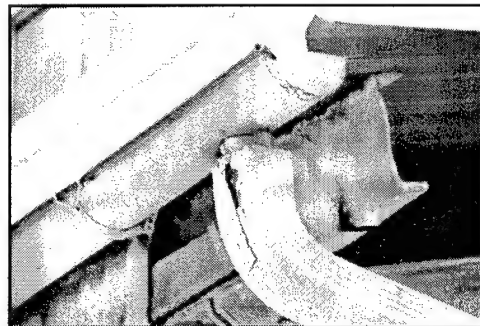
Figure 37. Original half-round gutters shall be maintained; the nonoriginal downspouts should be replaced with original style when they have deteriorated.

- Retain original characteristics instead of replacing with incompatible materials. Where repair or replacement is necessary, use gutters and downspouts that have compatible detailing and material. See Figures 36 and 37.
- Replace deteriorated noncompatible gutters and downspouts with those compatible to the original. See Table 2 and Figure 38.

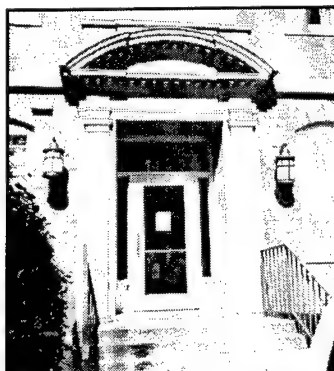
Figure 42. Entrance maintains similar proportions as the original within historic door surrounds.

- Doors and their surrounds that define the historic character of the building shall be retained and preserved. Retain, repair, and maintain historic hardware where it exists. See Figure 42.
- Replace deteriorated noncompatible doors with doors compatible with the structure. Replacement hardware shall be compatible. See Table 4.

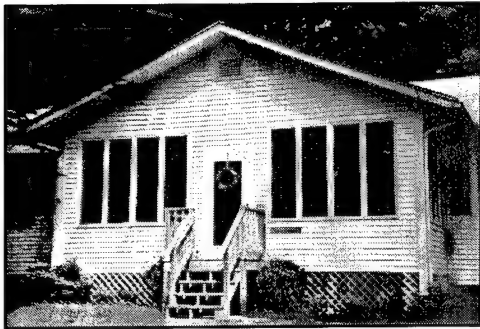
Figure 47. Enclosed porch is incompatible and distinct, and not reversible.

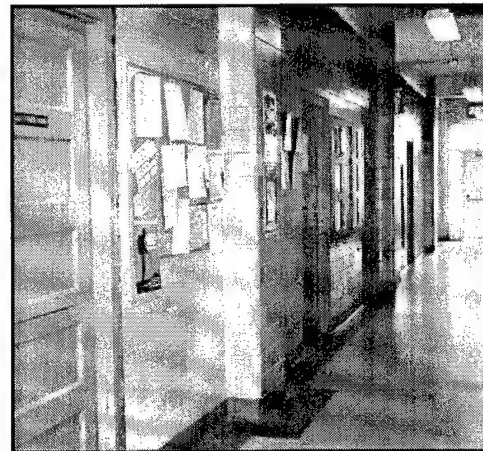
Figure 77. Bulletin boards that penetrate through the wall can be intrusive to the original finishes.
